Bank Erosion along the Rajang River in Malaysia

Kazuhiro YUHORA*, Ryoji SODA** and Satoru WATABE***

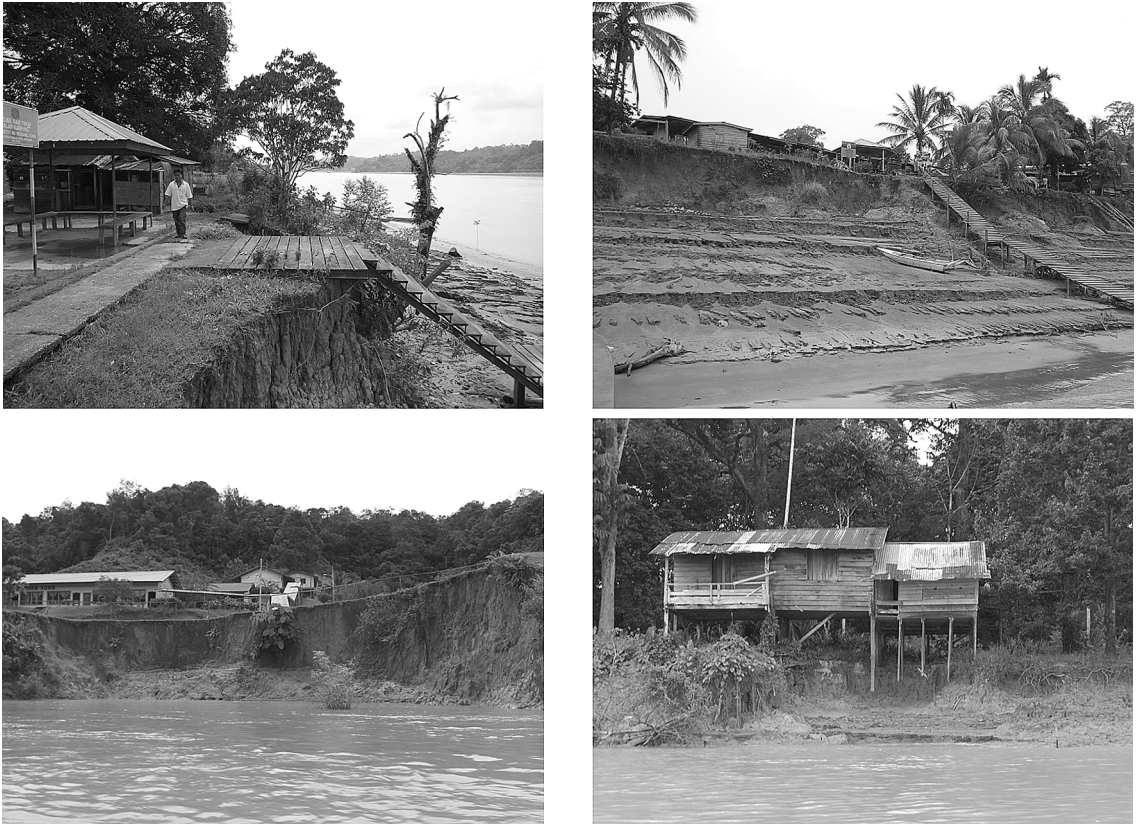
Photo 1. Eroded banks.

In the middle reaches of the Rajang, riverbank erosion has become a serious problem for local people (Photo 1). In the last few decades many longhouses in the area have been affected by the erosion and forced to move inland to escape from the collapse. Recently, the rise of longhouse relocation costs and shortage of flat land make the problem even more serious. Besides, there are a lot of public facilities such as schools, clinics and small market towns, most of which are also seriously damaged by the riverbank erosion.

We hired a longboat to observe the condition of the riverbank in the middle reaches of Rajang. We found that bank erosion is more serious at the place of village settlement and public facilities. On the bank where the longhouse or farmer's hut are located, many jetties are damaged by pier scour (runoff of soil), and some houses and huts are almost collapsed because of the riverbank retreat. Schoolyards in particular are severely eroded probably because of the lack of vegetation (cover crop) at the site (see the left below of Photo 1).

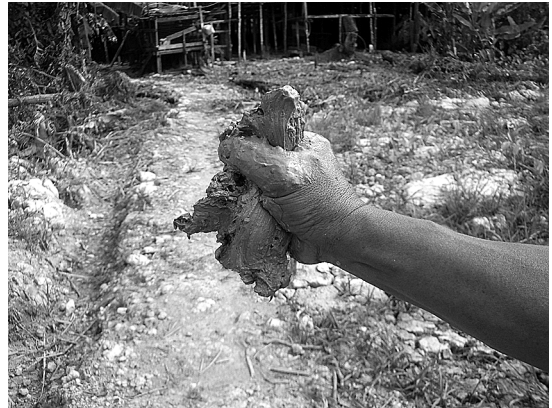
Photo 2. Clay soil.

Apart from sedimentation on the toe of slope, erosion usually occurs on the upper part of the bank, making a steep cliff on the slope. So far as observing the outcrop of the eroded bank cliff, the geological structure in the concerned area is almost the same. The banks were originally covered by alluvial soils of dark reddish brown color, which have been undermined by the erosion. At present, somewhat consolidated clay appears at the lower part of the bank. As a result of the erosion, we can see two different types of soils on the outcrop. While the lower part is a gray colored clay with high-viscosity

that is relatively tolerant to erosion (Photo 2), the upper part is more subject to erosion with reddish/brown silt and sandy soils. The degrees of erosion differ according to the type of soil.

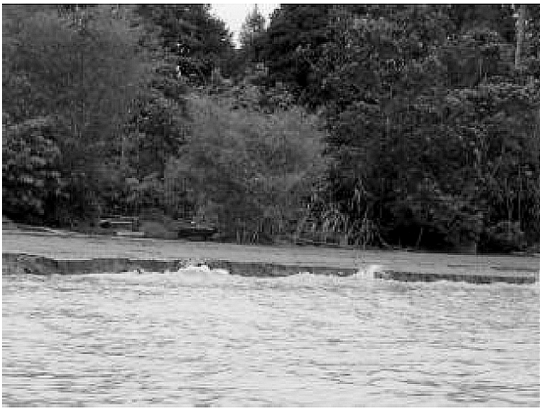
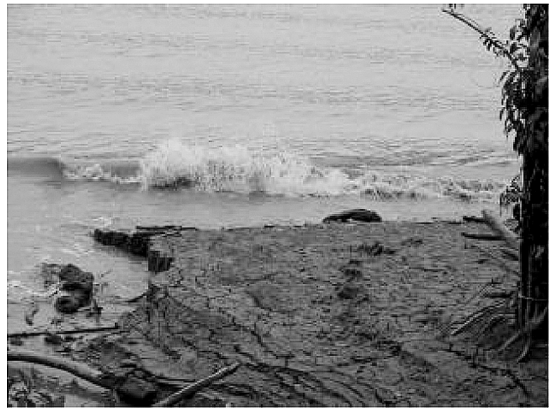
Photo 3. Vessels and vessel-induced waves.

The Rajang has a very low water velocity and there are little surface waves, but we can see vessel-induced waves reaching the bank. Local people believe that these waves have a damaging effect and are likely the causes of the riverbank erosion. Although there is no record on the exact number of boats, ships, vessels sailing across the Rajang, it is estimated that at least a few hundreds of ships and vessels (including boats) sailing every day. Express boats in particular, induce relatively big waves (Photo 3). At the time of high water level this wave can undermine sandy and silt soils of upper part of the bank slope.

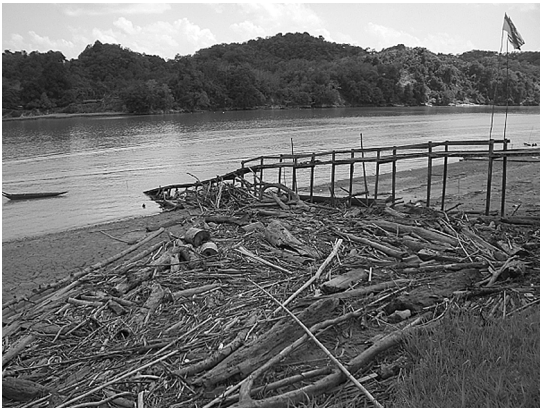
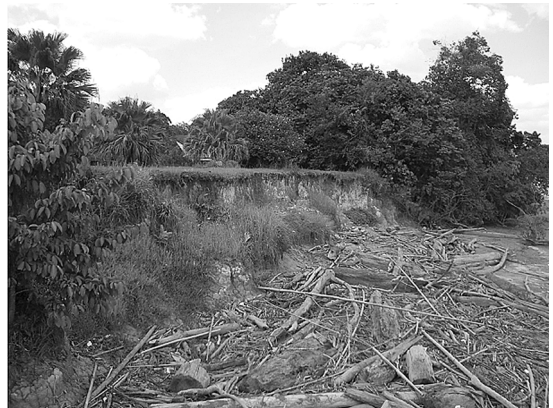
Photo 4. Drift timber.

Driftwoods and dredging work are also possible factors of the erosion. In the dry season we can see driftwoods retention (see Photo 4). When these woods washed up by the current during high water level, they would damage the bank slope.

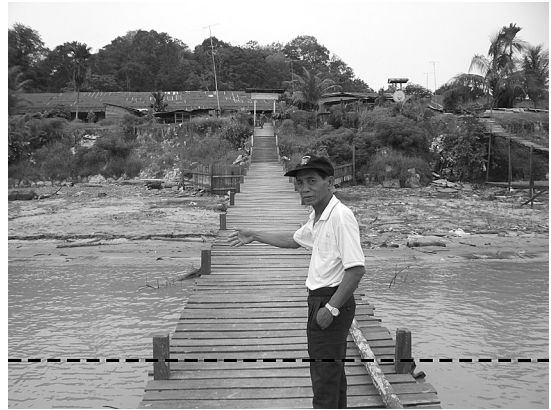
Photo 5. An Iban village chief pointing the past riverbank.

Almost all of the old residents state that the Rajang is gradually widening in the last few decades. In Photo 5, a chief of an Iban village near the Dap Town is showing that the riverbank of thirty years ago was around the broken line, more than 50 meters anterior from the existing bank. He also says “when I was young we could easily swim across the river, but nowadays it is impossible because the river has been widen and the water velocity has become faster.” This kind of statement was heard

throughout the middle Rajang. According to the interview with local residents, the riverbanks have been eroded since the 1970s. The length of eroded land is estimated 20–50 meters, that is, an average of 50–150 cm of land is lost every year.

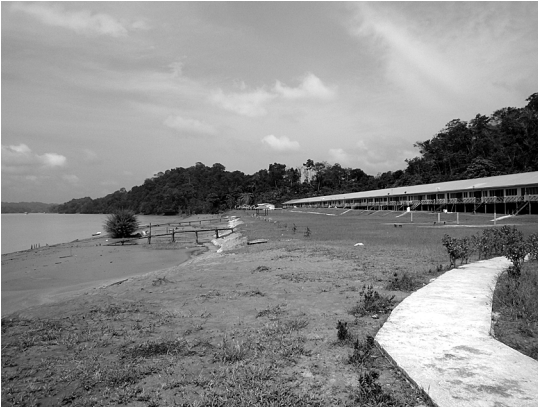
Photo 8. Constructed slope at Nanga Beguan.

Photo 8 shows a longhouse in Nanga Beguan near a little downriver from the Song Town. In 2003 they could obtain a government subsidy to make a gentle slope on the riverbank. This slope slackened the pace of erosion, but without recovery of vegetation, erosion would be accelerated again in the near future. Although longhouse residents are aware of that the slope has been less effective as time advanced, they do not take any further action on the bank protection.

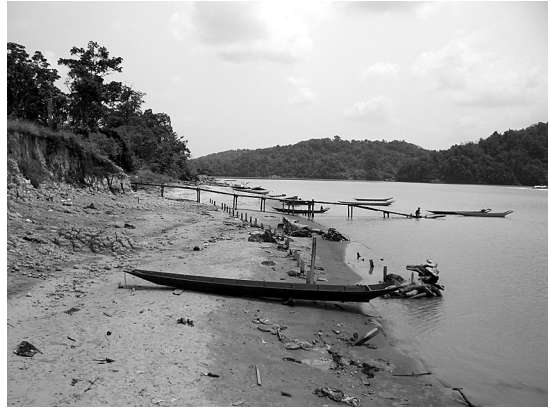
Photo 9. The wreckage of eroded sheet pile walls.

Another case is in Nanga Mam, where longhouse residents established sheet-pile walls for several times in the last 20 years to mitigate the effect of water velocity and vessel-induced waves. However, the wave-braking walls were collapse in a few years, and afterwards, they never done any bank protection work (Photo 9).
